Challenging Management of Two Broken Instrument in a Severely Curved Canal: A Case Report

The aim of the article is to describe the instrumental management protocol of the bypass of two fractured endodontic instruments, one of them partially extruded beyond the apical foramen in a severely curved canal.

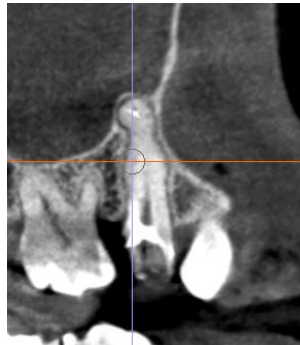
Fig. 3. Sagittal Section.

The position of the apical broken file was not clear in the periapical radiograph, so a CBCT was performed to determine its exact position with the apex. It revealed later that this one is extruded 2 mm from the apex and it also revealed a periapical lesion (PAI= 3) close to the maxillary sinus. CBCT also showed that the canal configuration was type 6 of Vertucci's classification.

[The coronal section (Fig. 4) showing the extruded file not visible in its correspondent sagittal section (Fig. 3)]

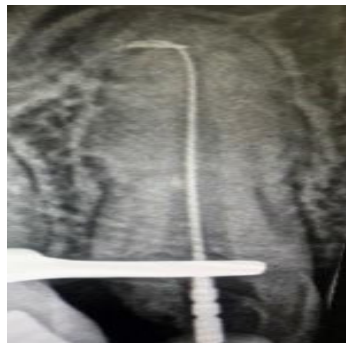
Fig. 5. X-ray file in place.

Afterwards, k-file number 8 was sharply pre-curved similarly to the canal’s curve then gently introduced with withdrew motion until a catch was felt. A tactile feeling confirmed the engagement of the file between the broken files and the root canal. This process was repeated with SS k-file number 10 then a customized 12 K-file made by cutting 1 mm from the tip of a K10 file. Working length has been determined with an apex locator and confirmed radiographically. K-file 15 and a customized k-file 17 were consecutively used. The intermediate size made the negotiation of the apical third of the canal smooth and more secure until full glidepath was done with a mix of K-files and Niti glidepath files (19/0.2). Finally, the apical third was prepared with thermally treated Endostar Azur 20/0,4.
